O 3000-HP ROLLER GEAR TRANSMISSION DEVELOPMENT PROGRAM
Volume I - Summary Report

Sikorsky Aircraft

January 1977

**Final Report**

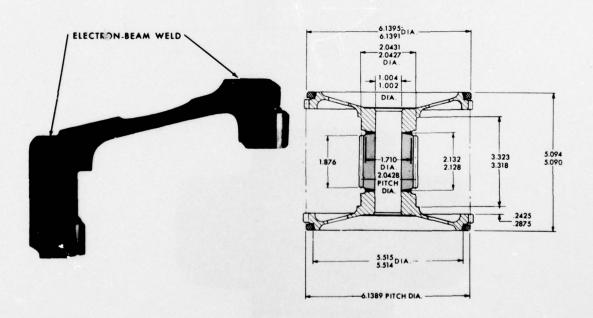
Figure 12. First-Row Pinion, Longitudinal Weld Configuration.

The initial design of these pinions incorporated a longitudinal electron-beam weld under the small diameter roller, Figure 12. Voids at the root of the weld produced stress risers from which fatigue cracks propagated. The pinion was subsequently redesigned to incorporate the butt weld joint shown in Figure 13.

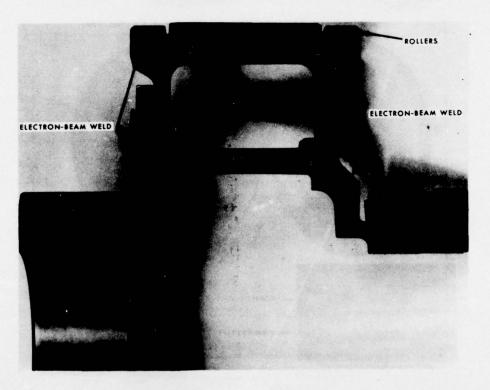
Figure 15. Second-Row Pinion, Original Configuration.

The original pinion design incorporated seven individual parts which required six electron-beam welded joints, Figure 15. Timing of the gear teeth was achieved by grinding the large diameter gear teeth relative to the small diameter gear teeth at the subassembly. The two case-hardened rollers were then welded and ground concentric to the large gear pitch diameter, whereupon the end gear and flange assembly was positioned (drilled and reamed) to line up the end gear teeth within +.0002 inch.

A fracture of the end gear and flange assembly, Figure 16, during initial testing precipitated a minor design change to increase the size of the relief between the gear and flange. A thicker blast shield was positioned between the exit of the electron-beam weld and the gear face, thereby enabling a wider and stronger electron-beam to be utilized to ensure fusion of the joint. A second fracture involving this gear design resulted from fatigue fracture propagating from voids at the root of the weld to the inside bore, Figure 17. Secondary fracture then originated from the stress concentration notch at the roller weld due to the large leverage load from the unsupported ring gear mesh forces. This fracture resulted in the redesign of the pinion, whereby all but two electron-beam welds were eliminated.

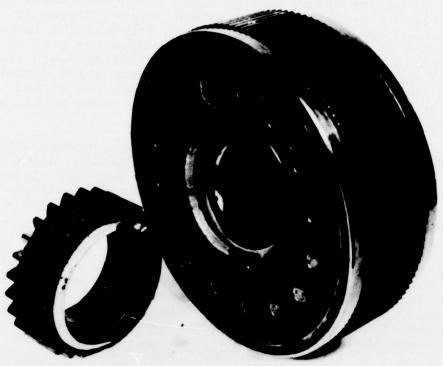
Figure 16. Gear/Flange Fracture.

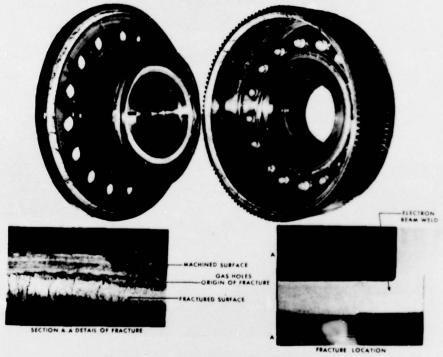
Figure 17. Second-Row Pinion Fracture.

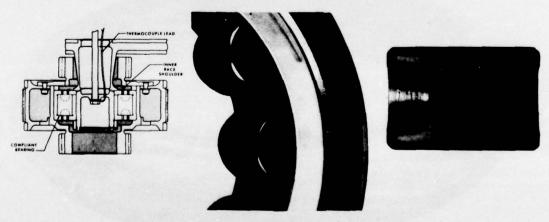
Figure 19. Compliant Roller Bearing.

Two types of bearings were assessed during initial development testing of the roller gear units. Both types had identical envelopes and were interchangeable in the second-row pinions. The compliant type bearing, Figure 19, is an advanced stateof-the-art cylindrical type roller bearing wherein both ends of the rollers are recessed. It was designed to accommodate the calculated slope due to the deflection of the bearing posts under maximum power. The hollow ended rollers were developed with the objective of increasing the range of misalignment (i.e., slope) which a cylindrical roller bearing can accommodate. By allowing the roller ends to deform, the load is redistributed to relieve the high stresses which normally result when a solid cylindrical roller bearing is subjected to misalignment. Testing of the roller gear unit with this type of bearing revealed insufficient axial clearance between the roller and the inner race shoulders and resulted in heavily scored inner race shoulders from contact with the end faces of the rollers.

The compliant bearings were replaced with spherical roller bearings and no further testing of the compliant bearings was undertaken.

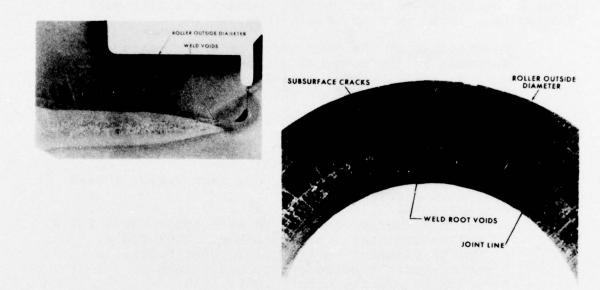
Electron-beam welds are susceptible to porosity and spiking at the root of the weld. Figure 20 is an example of porosity which occurred in the initial design of the first-row pinion. Also visible is the incomplete fusion resulting from misalignment between the electron-beam and the seam. These weld defects caused cracks to propagate to the surface of the first-row pinion roller and resulted in extensive spalling of the roller surface. It is believed that the porosity results from the release of gases dissolved in the metal or trapped in the joint to be welded. Although welding is accomplished in a vacuum, the pilot diameter press fit that is used to position the two parts can trap gases which are released during the welding process.

Figure 20. Weld Porosity, First-Row Pinion.

Although missed seam defects can be corrected by rewelding the area with increased power, this approach could not be utilized on this weld joint. Since the weld itself lay beneath a carburized case-hardened roller, the initial welding parameters were developed to minimize the amount of heat generated in the component to preclude tempering the hardness of the roller. An increase in the power intensity of the beam would have resulted in a "softer" roller and an undesirable change in the grain structure of the carburized case.

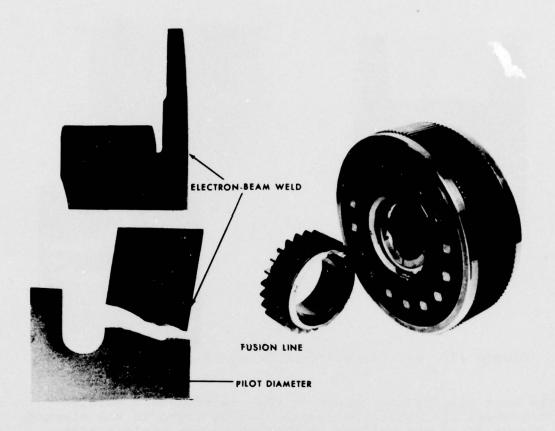
Incomplete fusion of the weld seam was further exemplified when a second-row pinion small diameter gear separated from the flange at the electron-beam weld joint, Figure 21. Examination revealed that although complete weld beam penetration had been achieved, fusion had not occurred where the center of the weld missed the mating surfaces. To ensure complete fusion, a more powerful welding beam was used. This required a thicker blast shield to be placed between the flange and gear to prevent metal spatter from pitting and damaging the end face of the gear.

Figure 21. Incomplete Weld Fusion, Second-Row Pinion.

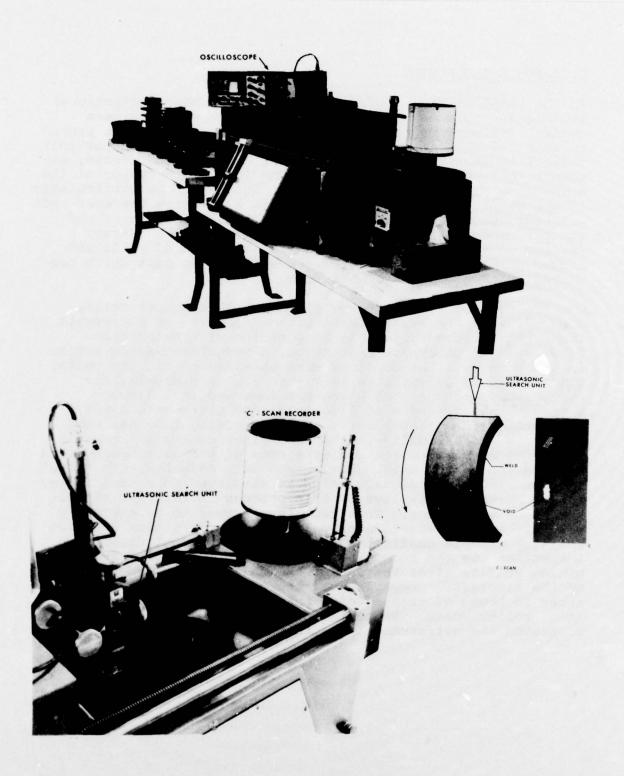
The fracture of the first-row pinion small-diameter roller from voids in the weld spurred the development of ultrasonic inspection of the welds. In cooperation with Automation Industries of Danbury, Connecticut, a technique was developed in which facsimile recordings were obtained of all the welds. This method is illustrated in Figure 23. A piezoelectric search unit and the test piece are immersed in a liquid whereupon short bursts of high-frequency ultrasonic waves, generated by the search unit, are transmitted into the test piece. A discontinuity in the test piece causes an acoustic impedance mismatch which reflects some of the ultrasonic waves back to the search unit. The search unit converts this "echo" into an electrical signal, which is displayed on a cathode ray Permanent displays of this process on recorder strips are known as C-scans. This technique proved to be extremely valuable in the detection of welding flaws. Perhaps the most striking example confirming the reliability of ultrasonic inspection was the recording of cracks in the second-row pinion rollers after testing of the roller gear transmission on the aircraft. Comparison of the C-scans taken before and after 50 hours of transmission testing revealed cracks in the lower roller welds. Removal of the degraded area (Figure 24) confirmed the ultrasonic inspection results.

Figure 23. Ultrasonic Inspection of Electron-Beam Welds.

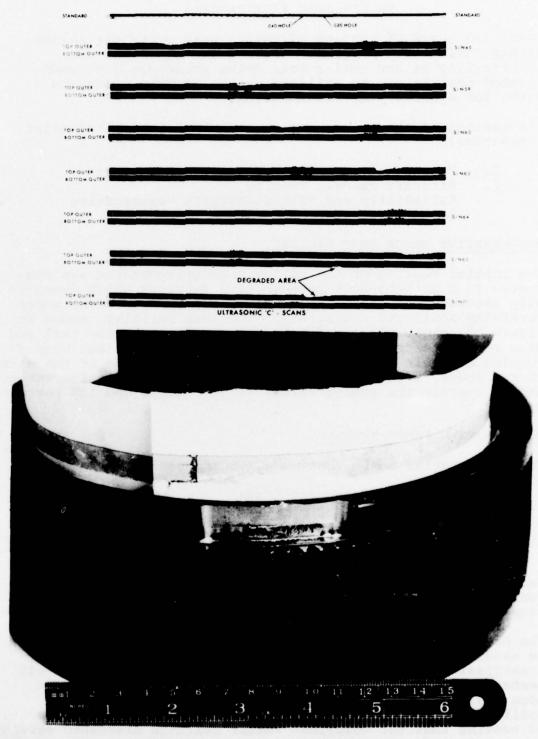
The most significant change in the electron-beam welding procedures resulted from cracks that appeared in the electron-beam welds of the rollers of the second-row pinions after aircraft testing of the roller gear transmission. Ultrasonic inspection of the welds showed indications of cracks that were not detected prior to the commencement of testing. Cracks were found in six of the seven second-row lower roller welds. Examination of the ultrasonic C-scans shows that degradation occurred along a line associated with weld pullout.

It was concluded that the fracture that initiated from the exit side of the weld at the interface of the melt and heat-affected zones probably resulted from weakened grain boundaries and excessive residual stresses due to welding. As a result, the stress-relieving cycle was changed from 2 hours at 275°F to 5 hours at 325°F, and was to be accomplished immediately after welding.

Figure 24. Cracked Lower Roller Weld, Second-Row Pinion.

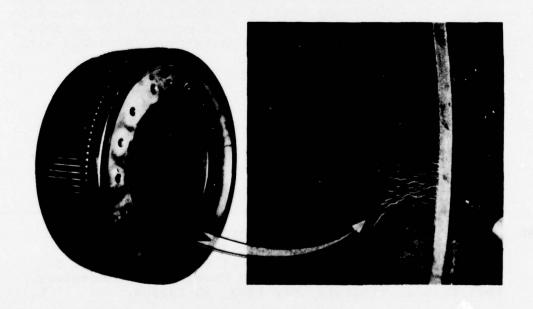
Magnetic particle inspection revealed cracks in the bearing bore of the second-row pinions (Figure 27) originating from the stress riser resulting from the configuration of the weld. Fatigue cracks were also found in the gear/flange weld of the second-row pinions originating from a series of voids along the weld line.

Figure 27. Second-Row Pinion Bearing Bore Cracks.

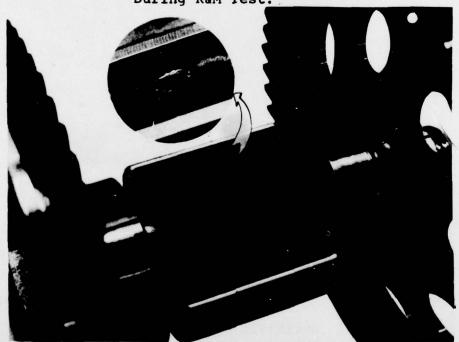
Figure 32. First-Row Pinion Tooth Spalling.
